44 MARKET ST – REFURBISHMENT OF A DUAL DUCT BUILDING

DR PAUL BANNISTER

ABSTRACT

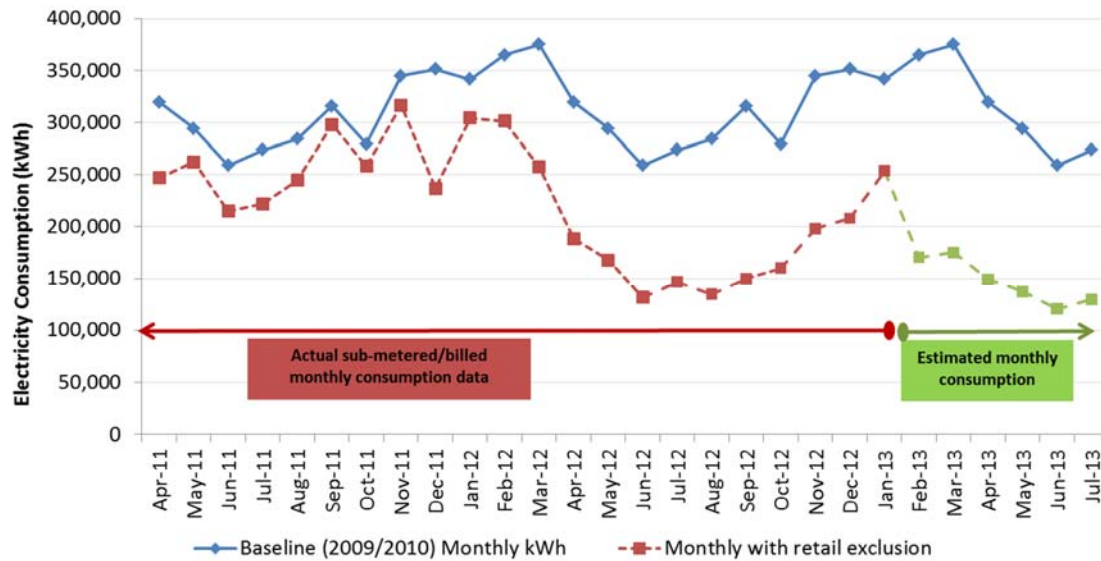
consumption trend is illustrated graphically in Figure 6 and Figure 8. Using an average tariff of 24.8c/kWh for electricity and 1.75c/MJ for gas, that equates to a \$340,000 annual cost saving, equating to a 12 year payback, which is good given that the capital costs included end-of-life replacement for the controls.

Figure 6: Base building electricity consumption trend

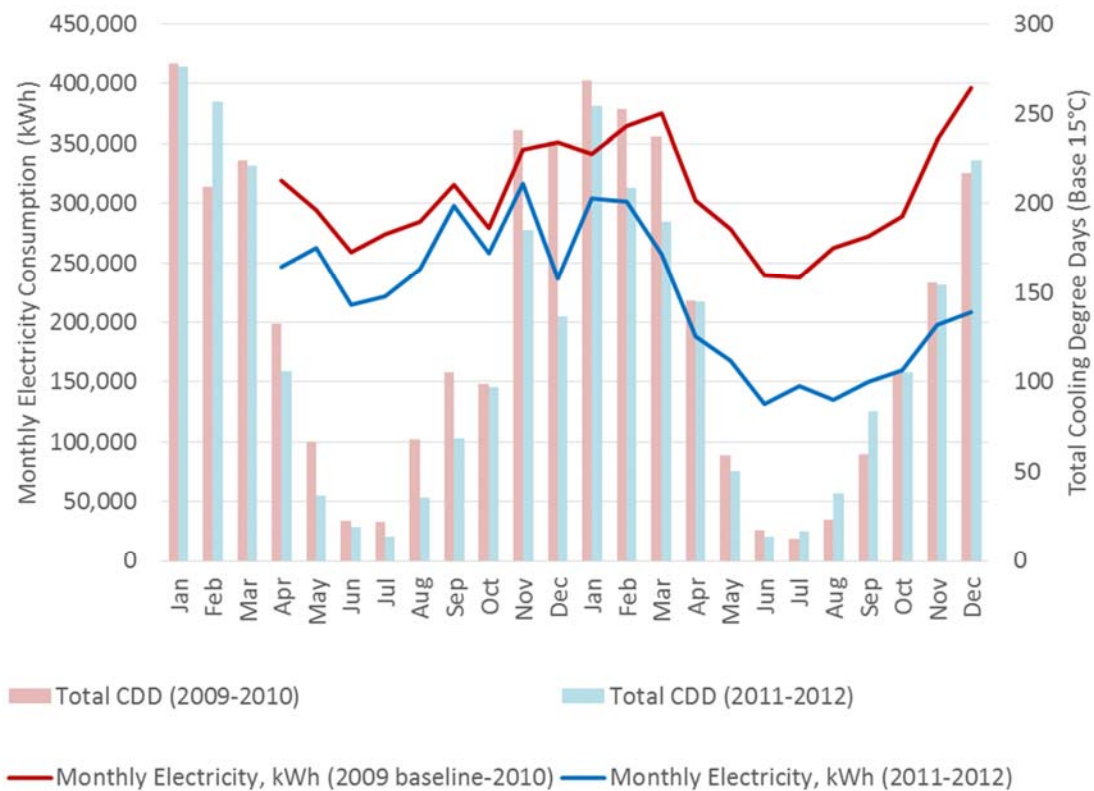
Note that the benchmark in Figure 8 is indexed back to 2009 as 2010-2011 had significant levels of vacancies. The reason for the high gas consumption between April and September 2011 is not certain, but could be due to lower levels of occupancy or to differences in weather from 2011 (Figure 7 and Figure 9) relative to that characterised in the 2009 benchmark.

Figure 7: Base building monthly electricity consumption trend against base 15°C total cooling degree days (CDD)

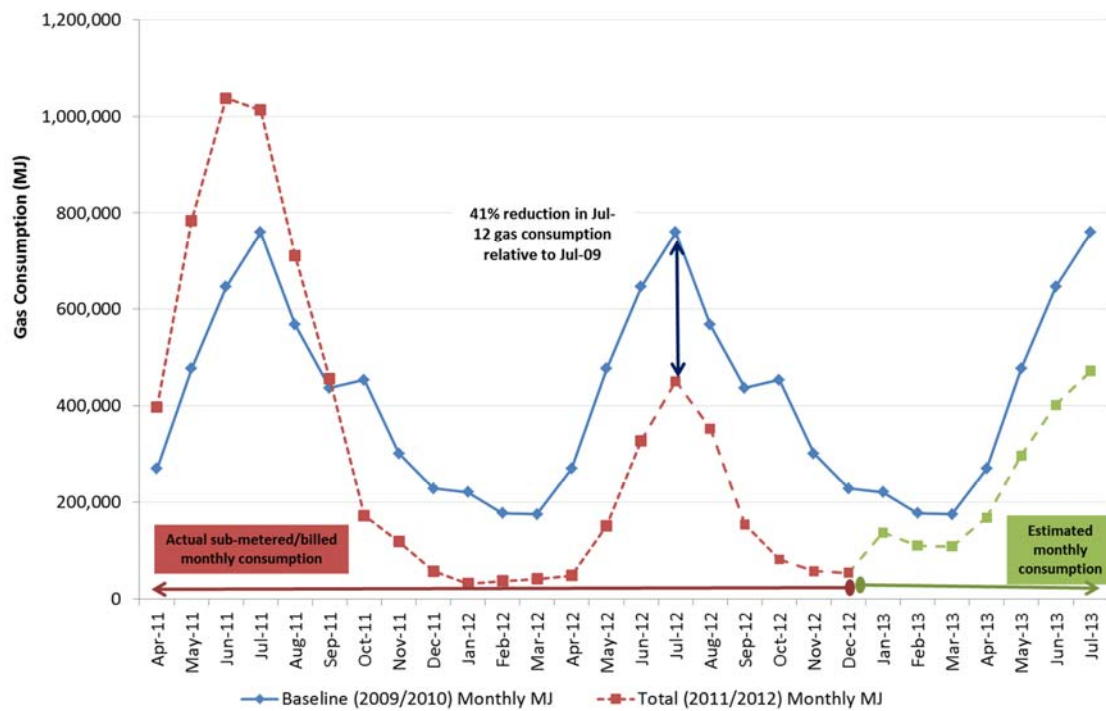
Figure 8: Base building gas consumption trend

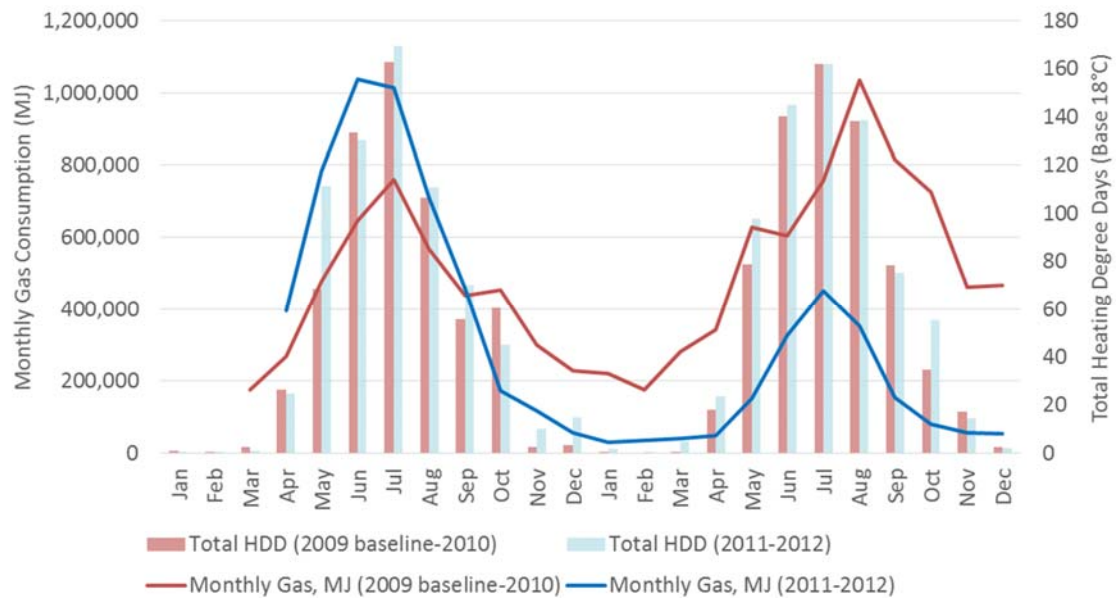
Figure 9: Base building monthly gas consumption trend against base 18°C total heating degree days (HDD)

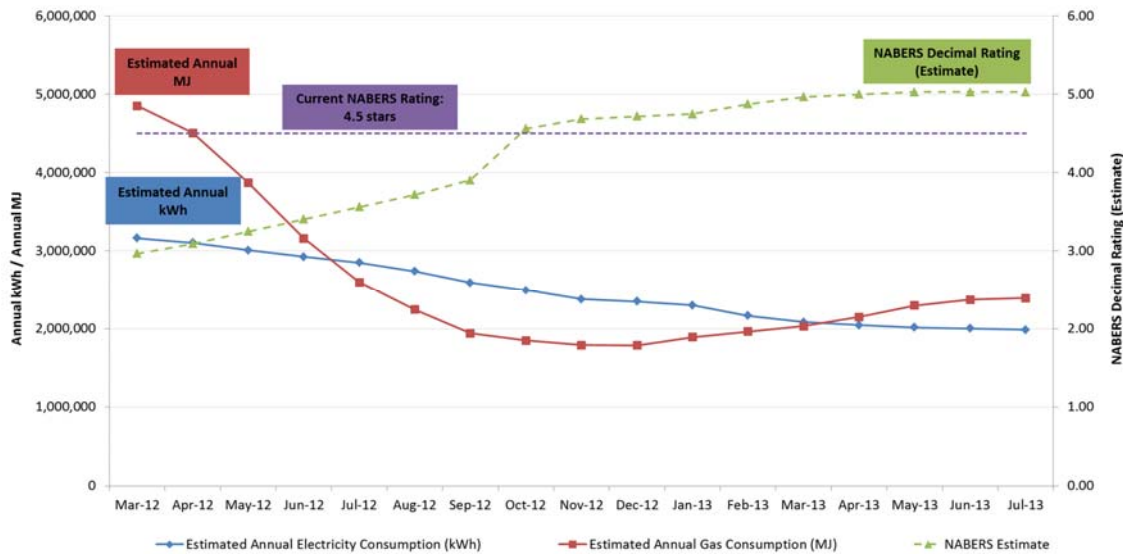
The estimated progress of the building's NABERS energy star (with 0% Green Power) rating relative to annual consumption is shown in Figure 10. The figures show positive results from the upgrade works completed in 2012. Applying the same percentage savings using the baseline electricity consumption trend projects that the retro-furnished dual-duct building will perform at 5 stars NABERS (without Green Power) by the anniversary of the conclusion of refurbishment works.

Figure 10: Monthly performance relative to star bands and progress towards 5 stars
